From: Rob Wilson
To: "Kirsten Dell-Hartgers"; Garry Van der Krogt
Cc: Margaret Waller; Les Wilson
Subject: RE: Cashmere High - id 340 - monthly fire alarm and sprinklr testing
Date: Monday, 11 February 2019 6:21:37 p.m.
Attachments: [REDACTED]

Project: Cashmere High School – Argest Major Defect Remediation

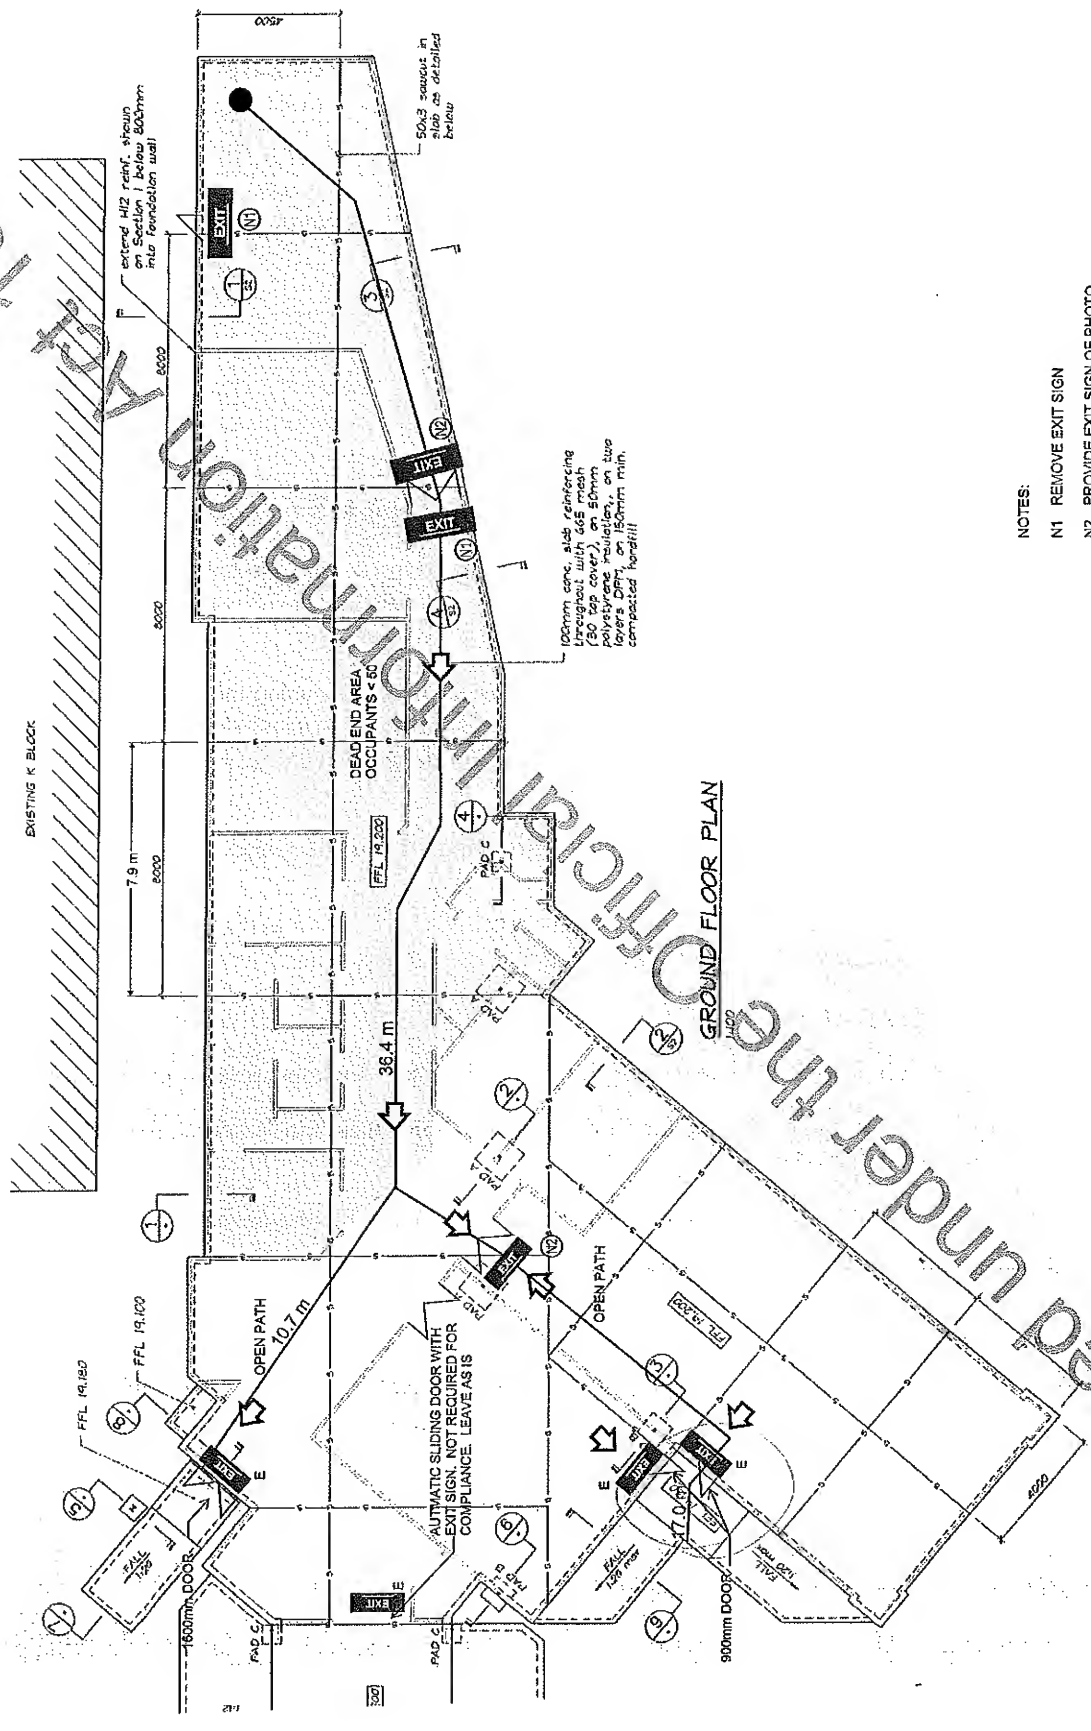
GROUND FLOOR PLAN

Illuminated EXIT signage is provided throughout. In accordance with assessment, the following changes to EXIT signage is recommended;

N1 REMOVE EXIT SIGN
N2 PROVIDE EXIT SIGN OF PHOTO
LUMINESCENT TYPE
E EXISTING EXIT SIGN TO REMAIN

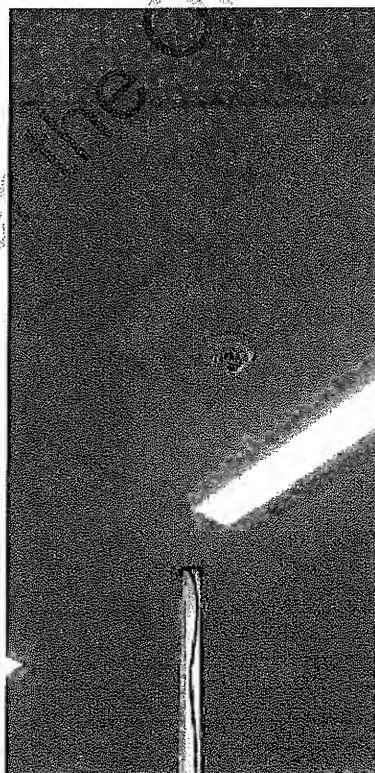
1. Classroom A9 cap on detector
Cover removed by Cashmere High School Caretaker – Confirmed by Optimus Fire
Photo show smoke with no cover

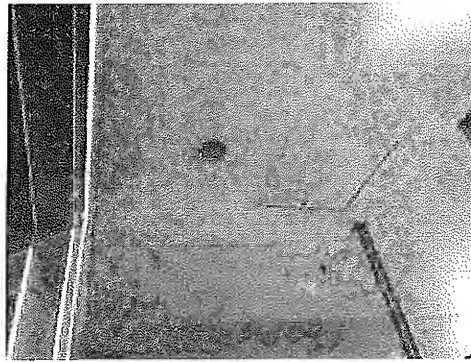
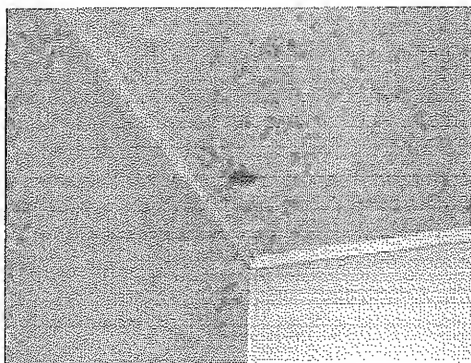
3. Gym toilet/changing rooms low sound levels

We investigated the evacuation devices in the Gym toilet/change areas and found several devices not working. Speakers which failed had no monitoring voltage which they should have if they were in circuit. We accessed the roof void and found five (5) open circuits on the evacuation feed. We expect these were wired for during installation but never brought through the gib. All five open circuits were junctioned which allowed some failed sounder to operate however two (2) still failed. Replaced these old Ampac sounders with new Pertronic ones which operated correctly. The old Ampac sounders were found to be problematic in the past including the grills falling off and were no longer sold as a result.

Photo 1 to 5 shows all 5 open circuits. Photo 6 & 7 show crimp joins to repair circuit. Photos 8 & 9 show old and new sounder in girls change. Photos 10 & 11 show boys toilet old then new sounders.

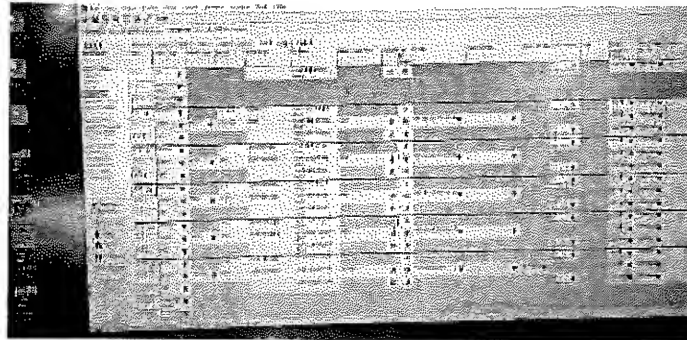
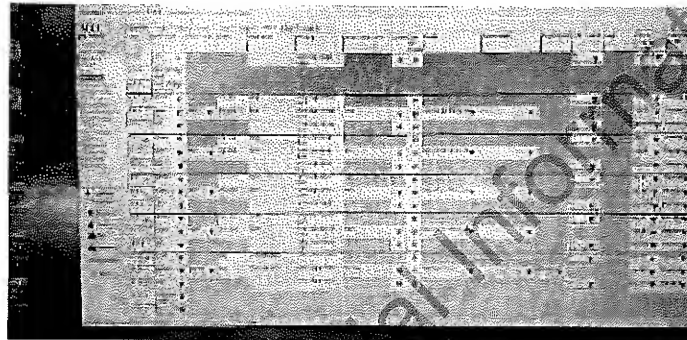
6. 5 minute delay on sounder operation and brigade calling on smoke detectors, sounders are to be instant the delay on the brigade calling is to remain
The 5 minute delay has been changed in the config as required. The fire system now has immediate evacuation on activation of a smoke detector, MCP or sprinkler. There is a 5 minute delay on the Fire Service calling on smoke detectors but not on MCP's or Sprinkler.
Photo 1 shows a snapshot of part of the config with smoke evac delay. Photo 2 shows the same section without smoke evac delay.
